Partnerships Making a Difference in Sligo Creek

In the past, civil engineers used to address drainage issues by designing stormwater drainage systems that quickly flushed stormwater into streams like Sligo Creek. These old methods unfortunately caused significant environmental damage by eroding the streambanks, exposing previously-buried sewer pipes (leading to sewer leaks in the stream), and killing aquatic creatures from the fast-moving water, increased salination in the Spring, and increased water temperatures during Summer. Today, professionals with various backgrounds are working together to address our stormwater drainage along Sligo Creek in smarter and more environmentally sensitive ways. On our Stormwater Tour along Sligo Creek Parkway between Colesville Road and the Beltway on March 30, 2019, we were shown many examples of how Montgomery Parks staff have worked together, and have sometimes worked with outside agencies, such as Washington Suburban Sanitary Commission (WSSC) and the Montgomery County Department of Transportation (DOT) professionals, to design stormwater management solutions that have enhanced Sligo Creek Park.

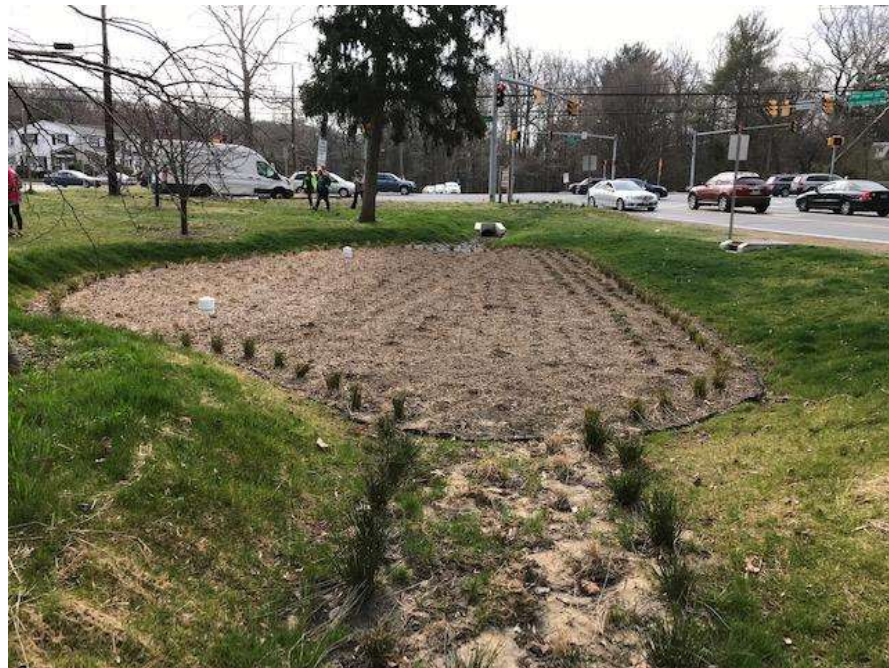
Site 1: Bio-Retention System at Corner of St. Andrews Way & Colesville Road and Sligo Creek Parkway

The first stop on our tour was at the bioretention system at the corner of Colesville Road and Sligo Creek Parkway. The bioretention system collects stormwater runoff from a 4-acre drainage area. While the bioretention system

looked dormant, soon nine species of plants will fill the mulched area. The mulch and soil root zone help absorb stormwater runoff and, using a process called phytoremediation, break down pollutants such as oil on roadways. The stormwater runoff collected from the surrounding roads and other hard surfaces when it rains percolates through the special bioretention soil.

Once the runoff is cleansed and cooled, it is collected in perforated pipes deep within the soil and piped to Sligo Creek. The street corner, once an eye sore, will soon be a source of beauty and color when the garden plants emerge. This project was made possible by Parks engineers working with the DOT, Parks biologists, and the plant growers at Pope Farm (the Parks nursery for plant materials).

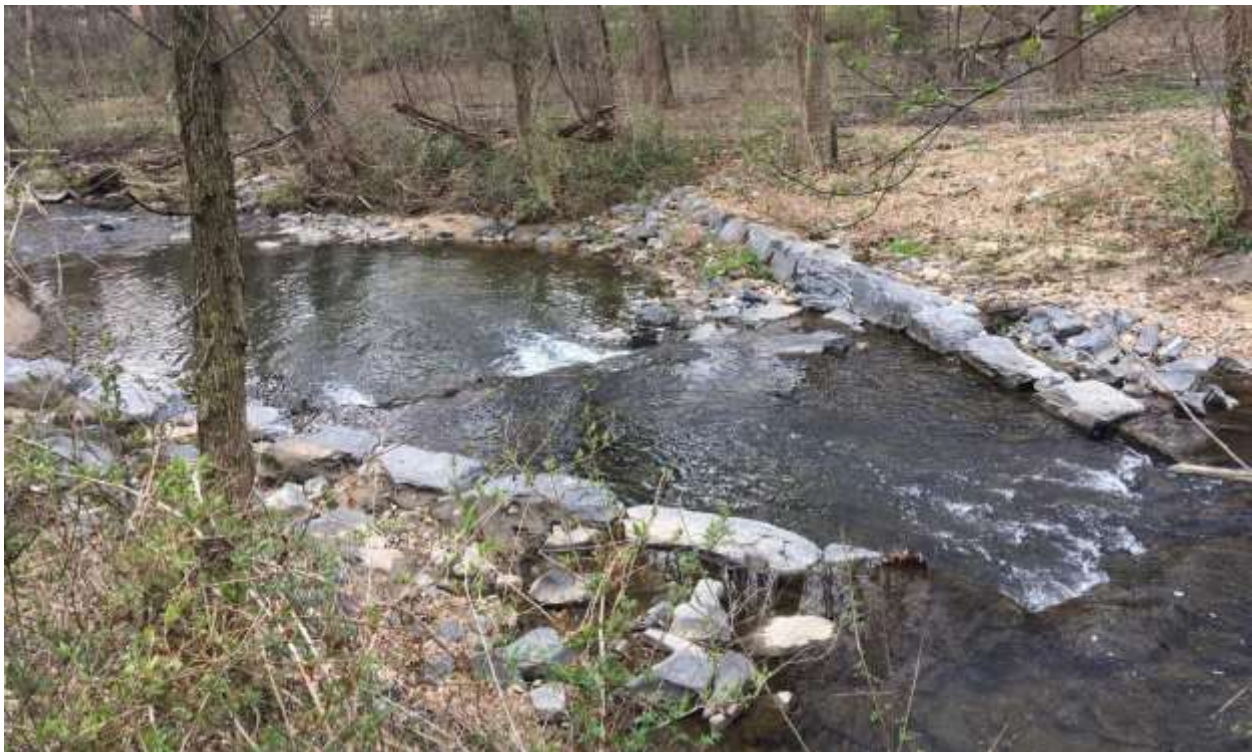
Site 2: V-Formation at Stream Stabilization Project

A short way upstream Sligo Creek, we were shown a [cross vane](#) stone structure with stone drops which channels creek water flow into the center of the creek. The stone V-formation directs the water to the center of the stream, protecting the stream banks from erosion, and the mini-waterfalls help improve water quality by increasing the oxygen content of the water. Working closely with biologists, the engineering staff carefully designed the stone structures to prevent fish blockages. The project was initiated to repair a leaking WSSC sanitary sewer as part of the WSSC Consent Decree. By using stones strategically to protect the sewer line by stabilizing the streambed, Parks staff was able to provide new habitat for creek critters.

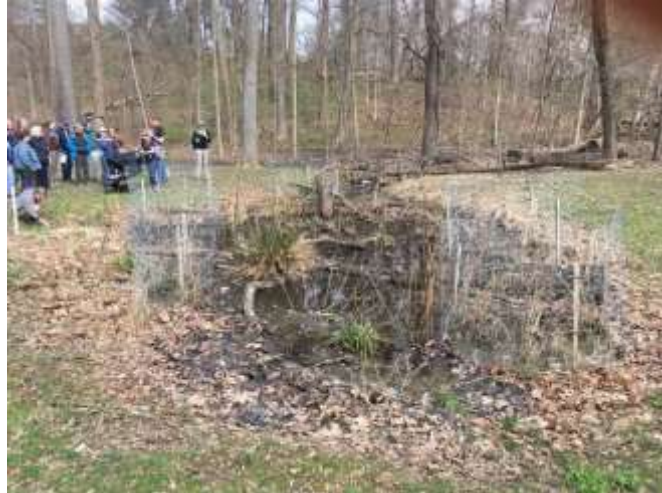
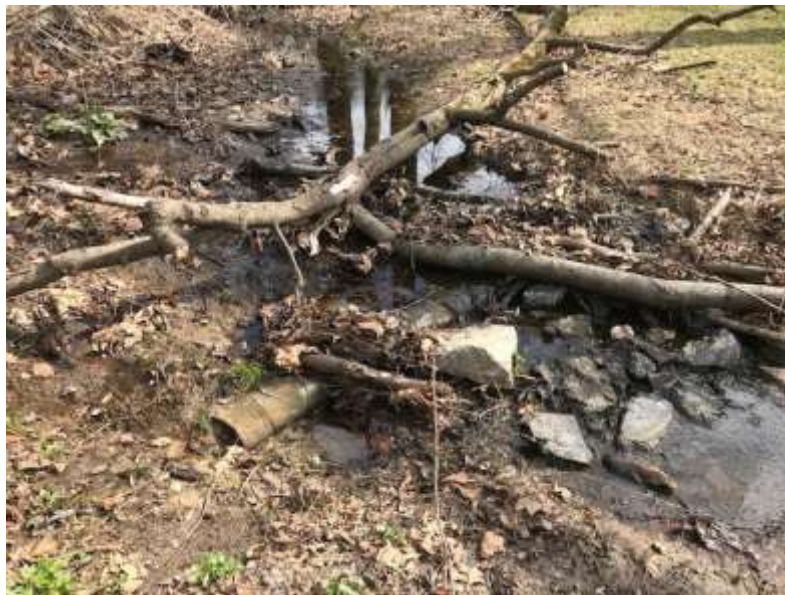
Site 3: Parkside Wetlands Restoration

We next visited a wetlands restoration site by Parkside. Because of the high ground water levels, Parks staff decided not to use techniques that encourage the infiltration of stormwater into the ground. Instead, logs and stone aprons were used to spread out the water in deep and shallow areas, and wetland plants were planted throughout the zone to create a healthy, complex ecosystem. Because it was still March, we were not able to see the vegetation,

but soon the site will be full of wetland plants. When asked about mosquitoes, Parks Natural Resource Specialist Matt Harper noted that a healthy wetland habitat will host many mosquito

predators. The steady flow of water through the wetland will also discourage mosquitoes, as mosquitoes prefer standing water. The design team included a tree expert who worked to ensure that nearby tree roots were not damaged during the installation work. Parks staff are monitoring how well the wetland is functioning.

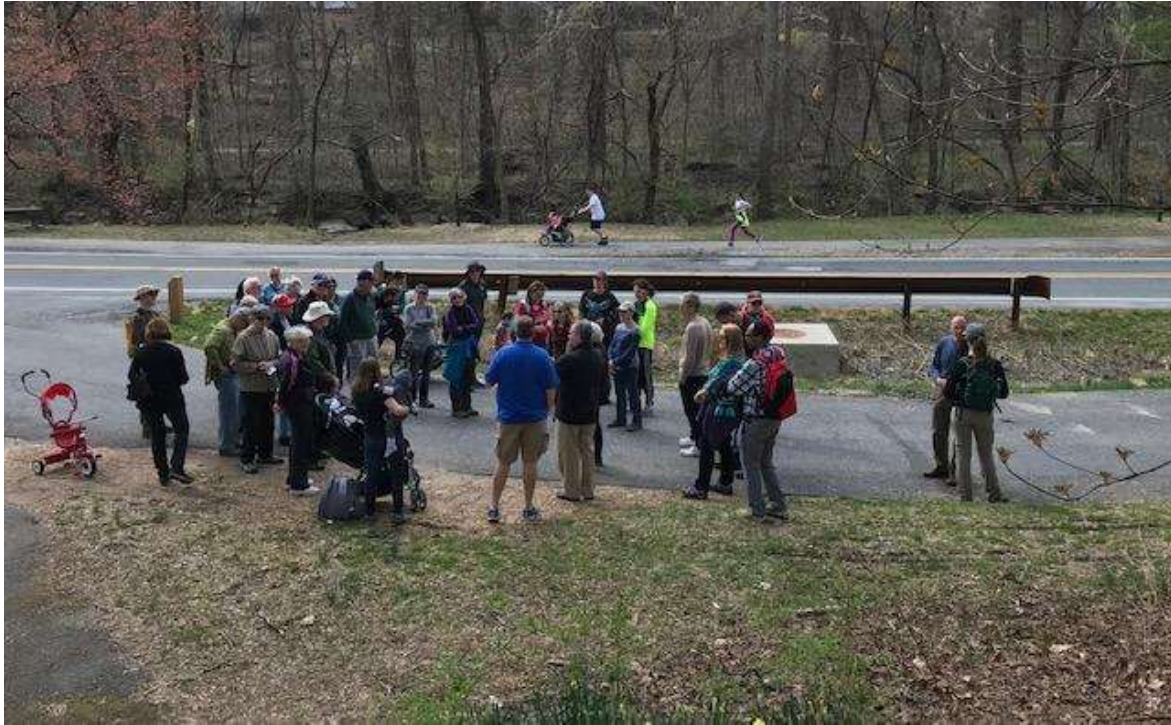
[Site 4: Bioretention System by Park Headquarters](#) (click hyperlink to see Before & After Photos)

The next stop was another bioretention system. At this stop we learned about the Parks staff of Pope Farm who are part of the team of professionals working on these projects. The Pope Farm staff work to provide plants that are the proper ecotype, which are plants carefully propagated from local sources, not just the correct species. Considering the plant's ecotype rather than just the plant species has resulted in creating habitat that provides maximum ecological benefits.

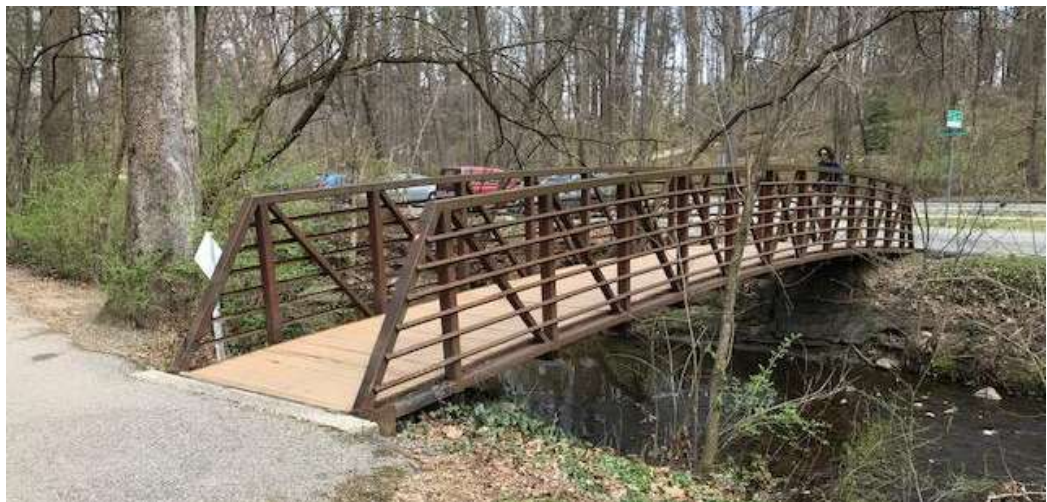
Site 5: Bridge scheduled to be Replaced by Edgevale Tributary

The next stop was the bridge over Sligo Creek near Brunett Ave. In June 2019, replacement of the bridge will begin, removing paving along Sligo Creek, restoration work along Sligo Creek, and addressing an exposed sanitary line and damaged stormwater outfall along what the staff referred to as the Edgevale Tributary.

Parks staff plan on “raising” the Edgevale tributary to reconnect the tributary stream to the floodplain. This project

will help restore the hydrology along Sligo Creek. By raising the Edgevale Tributary streambed, water will flow into the surrounding wetland soil instead of draining into the tributary as it has been doing because the streambed has been eroded. This erosion was due to excessive waterflow from extensive hard surfaces in the neighborhood during rain events.

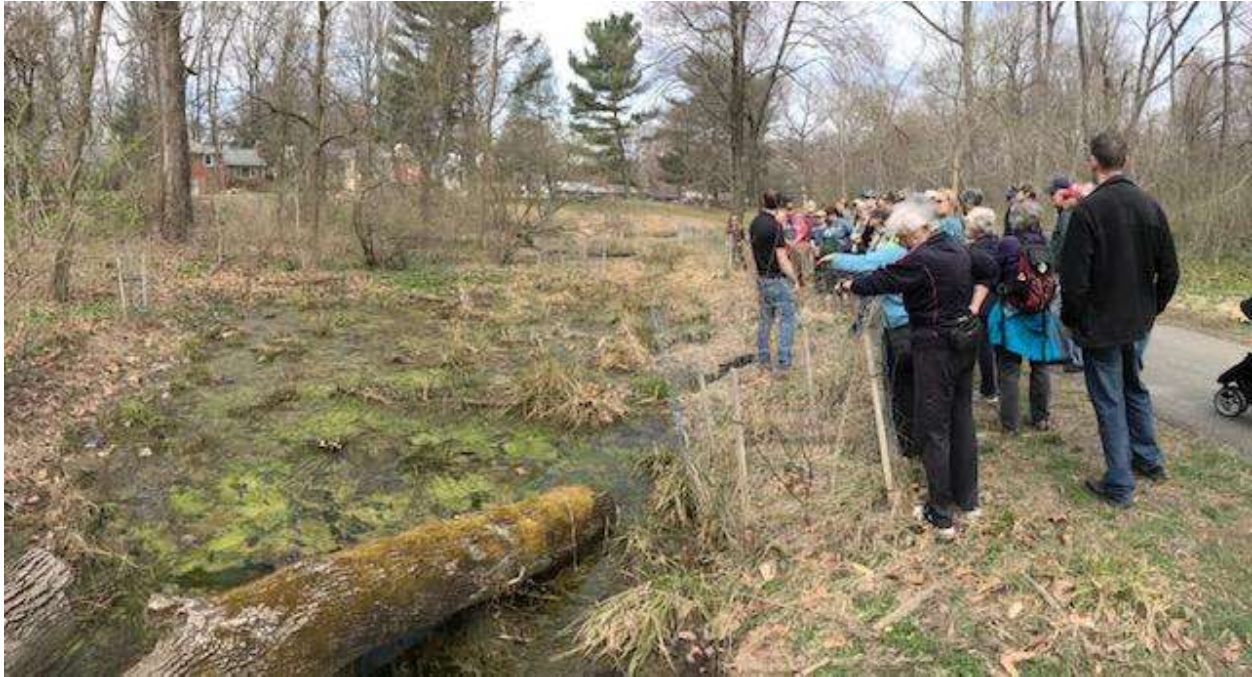
Site 6: Crosby Road Restored Wetland Site

The next stop was a restored wetland near Crosby Road. Not too long ago the restoration site was a monoculture of grass which was mowed with great difficulty, and mosquitoes were a problem since the area was a wetland without mosquito predators. By creating a complex healthy ecosystem with habitat including logs and plantings to support other wildlife, mosquitoes have been reduced. The area once hosted many Ash trees but the Emerald Ash borer is an exotic pest that has devastated ash trees in the area. These Ash trees were cut down and their logs were repurposed as habitat for the restoration project.

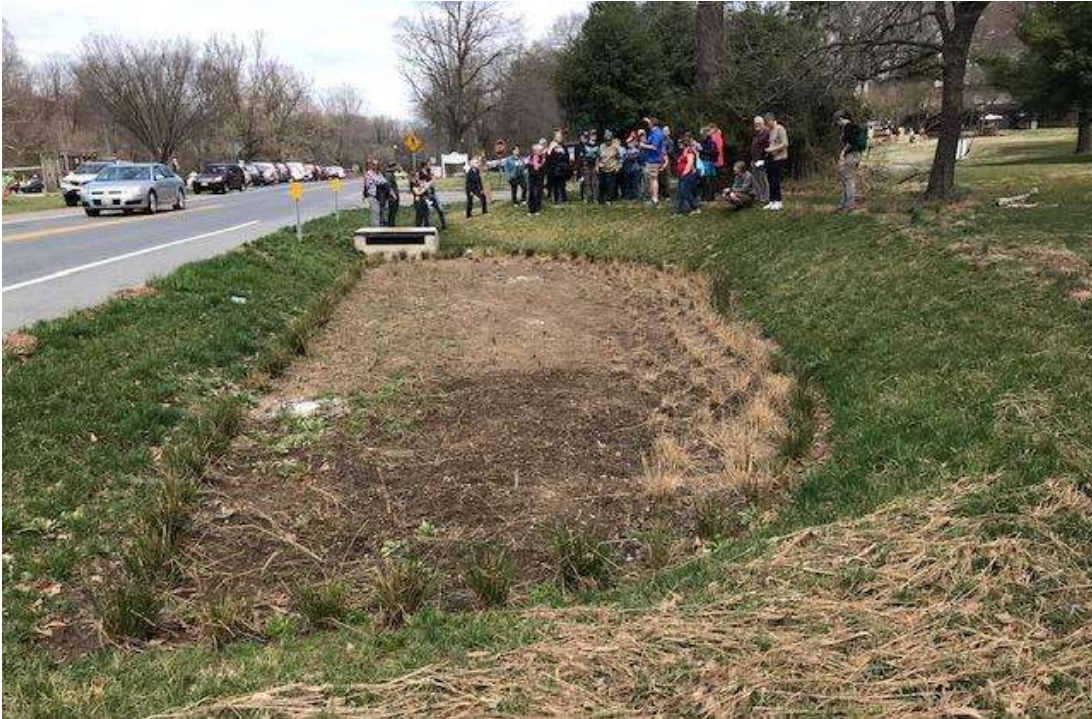
[Site 7: Bioretention System at Sligo Golf Course](#) (click hyperlink to see Before & After photos)

The last stop was one of the bioretention systems in front of the Sligo Creek Golf Course. Parks staff noted that in May the dormant gardens will be filled out with beautiful blooming flowers. Parks worked with the golf course to install stormwater facilities along the golf course property. Trees have also been planted. Additional projects are planned for the large asphalt parking lot.
